MW Polymers works in partnership with a the a Brisith utility firm using a P.E Repair Kit on a leaking fusion socket to immediaty stop the leak

Project Overview

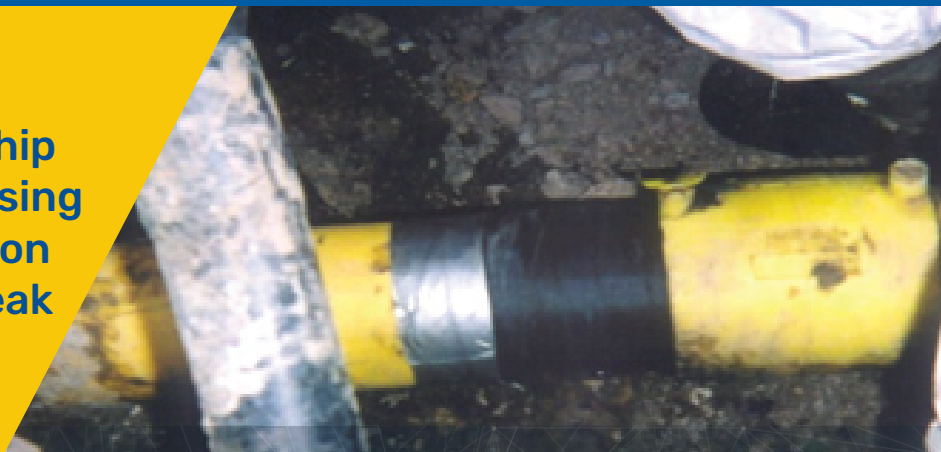
utility company responsible for managing and maintaining pipelines in the East Anglia region of the United Kingdom, encountered a challenging situation. They faced a critical issue with a leaking fusion joint within a polyethylene (P.E) pipeline, and what made the situation even more complex was the need to address this problem while the pipeline remained operational, under live conditions.

Furthermore, after the puncture damage has been addressed using the P.E Repair kit, an additional protective measure is taken by applying a material called Polyform™. This coating or material is specifically designed to enhance the pipe's resistance to future impacts. In essence, it acts as a protective shield, reducing the risk of similar damage occurring in the future.

The repair was executed with remarkable swiftness, allowing it to be conducted without interrupting the operation of the live main. This rapid response and the ability to carry out the repair on an active primary pipeline showcase the efficiency and expertise of the maintenance team involved. It ensured minimal downtime and reduced the impact on services reliant on the live main, underscoring the importance of quick and seamless solutions in maintaining the continuity of critical infrastructure.
