CASE STUDY

MW Polymers works in partnership with a USA Utility firm using Polyform™ on a 16"-60 psig dresser coupling for a gas utility company in the United States of America saving over \$25,000

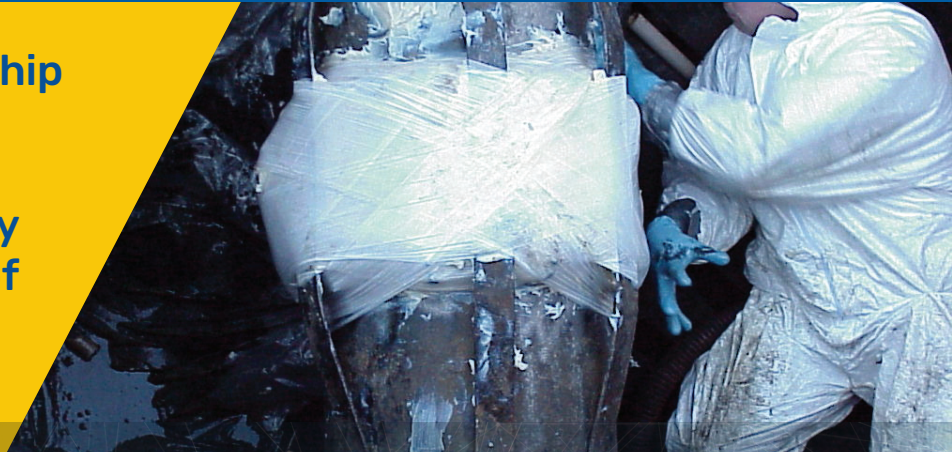
An American Utility company is currently grappling with a significant challenge related to the integrity of their 16"-60" PSIG Dresser coupling. This issue has arisen due to the deterioration and corrosion of the gasket, a vital component within the coupling system. The consequence of this gasket corrosion is the occurrence of unwanted and troublesome leaks along the barrel of the coupling. These leaks pose a threat not only to the overall functionality of the coupling but also potentially to the safety and efficiency of the entire system it is a part of.

MW Polymers undertook an intricate and all-encompassing strategy to confront the demanding issue of high-load vibrations occurring at a pressure of 60 psi. Their method encompassed the execution of a specialised welding procedure to affix sturdy straps, a solution aimed at efficiently dampening and controlling the disruptive vibrations. Following this, they meticulously employed Polyform™, a reliable sealing material, to address the affected area. In their pursuit of a durable and dependable seal, they took great care to wrap Polyform™ around the pipe with exceptional precision.

A comprehensive and highly efficient repair operation was carried out, achieving the full and successful sealing of the leaking pipe. This pipe was situated in a particularly challenging environment, as it was located within a tidal region, which presented unique difficulties. Given the circumstances, the repair had to be executed with an exceptional sense of urgency, prompting the use of Polyform™, a specialised and swift-acting sealing solution.
