## CASE STUDY

MW Polymers works with Ecoseal & Polyform™ on a leaking 10" medium pressure bolted flange located next to the motorway

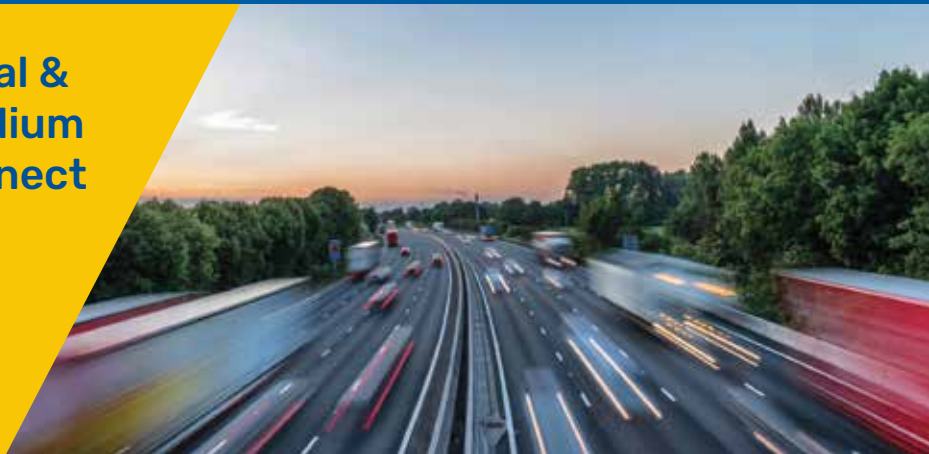
The project involves the remediation of a leaking 10-inch medium pressure bolted flange, which has been exposed following excavation. This flange is positioned in close proximity to a heavily trafficked motorway junction, where significant ground movement and vibration are common place. The current issue involves a leakage occurring at a pressure of 27 psi, necessitating urgent attention to prevent further environmental impact and potential operational disruptions.

After completing the grit blasting procedure, a medium pressure vent tube was carefully inserted into place. This crucial step ensured proper ventilation and pressure management within the system. Subsequently, a layer of Polyform was meticulously applied over the treated surface. This coating serves to provide a durable and protective barrier, enhancing the flange's resistance to corrosion and environmental stressors. Together, these measures contribute to the longevity and reliability of the infrastructure, particularly important in environments prone to mechanical strain and external impacts.

The result of inserting the medium pressure vent tube and applying Polyform following grit blasting is a strengthened and protected flange system. Here's a breakdown of the outcomes:
